**Historic District Commission
Staff Report: Courtesy Review
HDC2013-00605, 315 Great Falls Road**

RECOMMENDATION: Discuss proposed new rear addition and attached two-story garage, and provide comments concerning the project's compatibility with the historic resource in terms of design, massing, scale and impact of proposed construction on the overall character of the site.

EXECUTIVE SUMMARY: The applicant proposes two additions to the existing Colonial Revival style cottage: a rear 2-story addition at the rear northeast corner of the house and a two-story garage addition on the west side of the house. Staff recommends that the proposal could proceed to a Certificate of Approval application.

RE: Tree risk and condition assessment

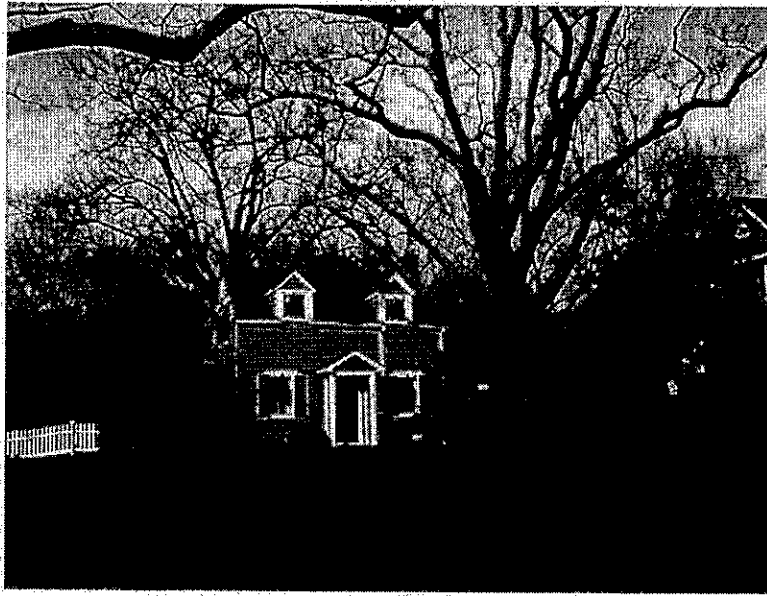
Front (South) Elevation

The subject property was locally designated in 2003 at the request of prior owners [Circle 5]. The house qualified for historic district zoning on the basis of its association with the National Register-listed resource at 307 Great Falls Road, known as the Bingham-Brewer House, and for its being a good example of the early 20th century Colonial Revival style. The foundation for the house was part of an outbuilding (barn or carriage house), and the current house served as a summer residence in the early part of the 20th century for family members of the Bingham-Brewer House. The house sits well back from the street, reflecting its original configuration as an outbuilding rather than a primary structure.

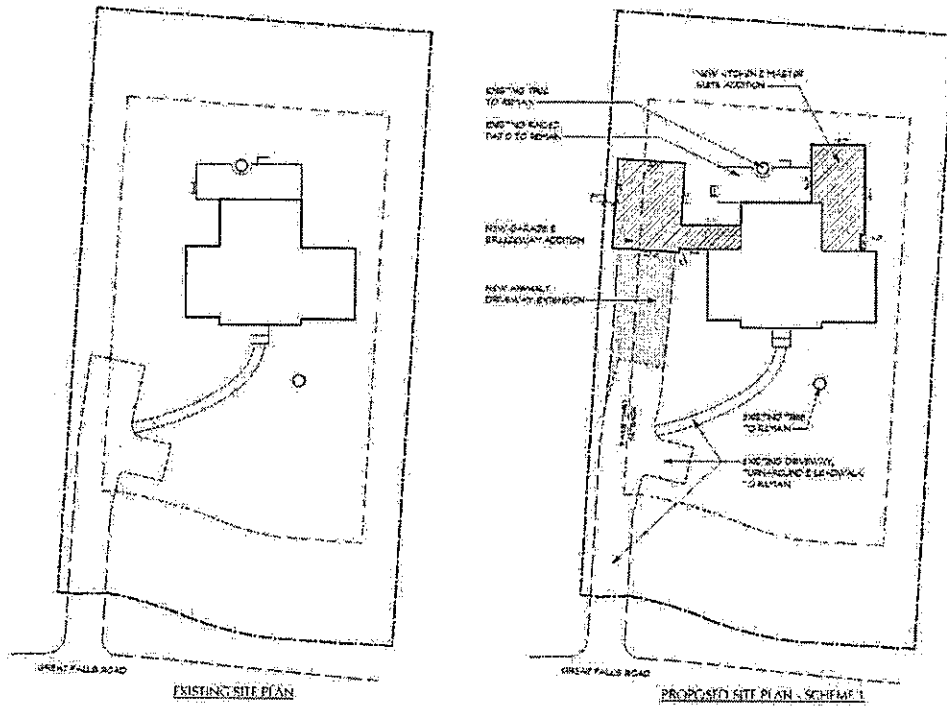
A-0.1 ARGENTIERI ADDITION
315 Chestnut Hill Road, Gaithersburg, MD 20878
1/15/2012, 1/15/2012 AND SITE PLANS
Scale: 1" = 20' 0"

The applicant proposes adding a two-story rear addition at the northeast corner of the house to provide a new kitchen and screened porch on the first floor, and a master bedroom suite on the second floor. The house currently has two bedrooms and one bath on the second floor, all of which will be retained.

In addition, the applicant proposes adding a two-car garage with an open room above, which can be used for a home office or for guests. This will be located along the axis of the existing driveway and connected to the house with a covered walkway.

The applicant has worked with staff to develop the project to this point. Minor modifications include increasing the distance between the garage and the house to avoid overwhelming the house.

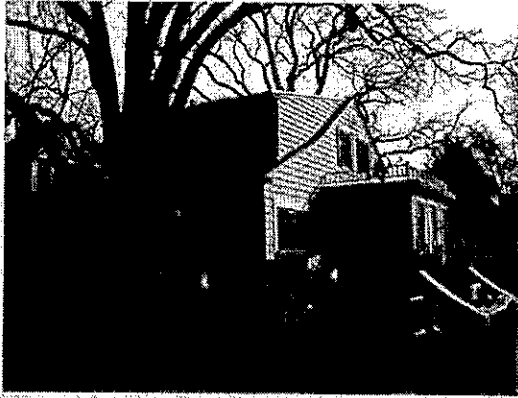
Rear with mature walnut tree

The applicant has been constrained by the site, especially because of the large walnut tree behind the house and the siting of the house due to its history as an ancillary structure to the historic property at 305 Great Falls Road. Staff met with the City Forester and the applicant on site to evaluate the condition of the tree. Following the recommendation of the City Forester, the applicant hired a certified arborist to assess the tree, in light of evidence of a lightning strike as well as its age. This was provided to the City [Circle 4-9]. The arborist recommends that the tree is essentially sound but with significant defects. He suggests that these be addressed by removing all the dead, damaged and defective limbs, reducing the crown by 10% over the next few years; and, consider the installation of a lightning protection system to avoid future strikes.

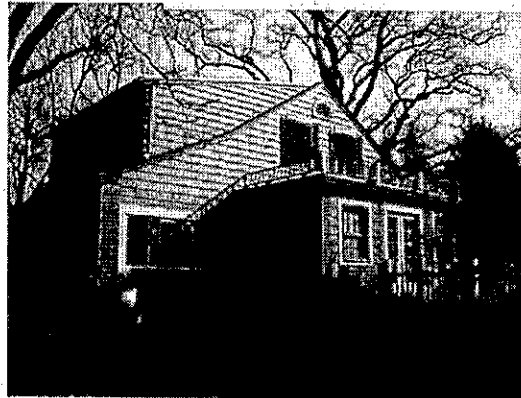
Rear and west side

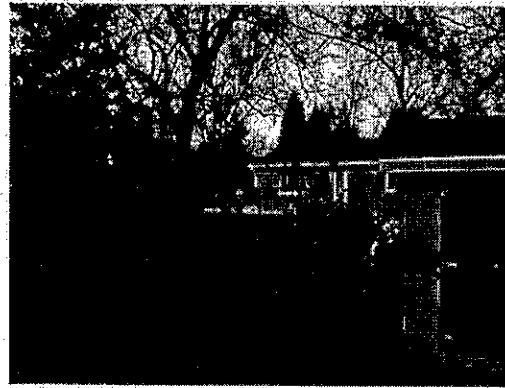
Backyard and shed, east rear yard

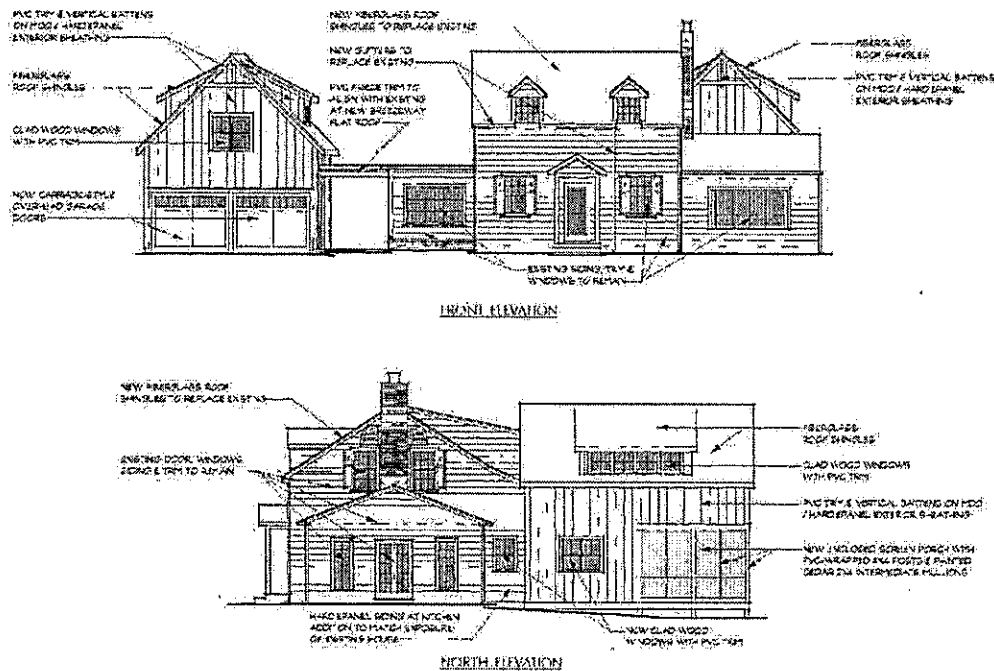
A-3.1 ARGENTIERI ADDITION
315 Cedar Falls Road, Rockville, MD 20850
PROPOSED ELEVATIONS
Scale: 1/8" = 1'-0"
7 Dec. 2012 \$1236

The proposal utilizes barn vocabulary for both the garage and the rear addition. This allows typical massing for roof and dormers that conform to the existing house, while clearly differentiating the new work from the old.

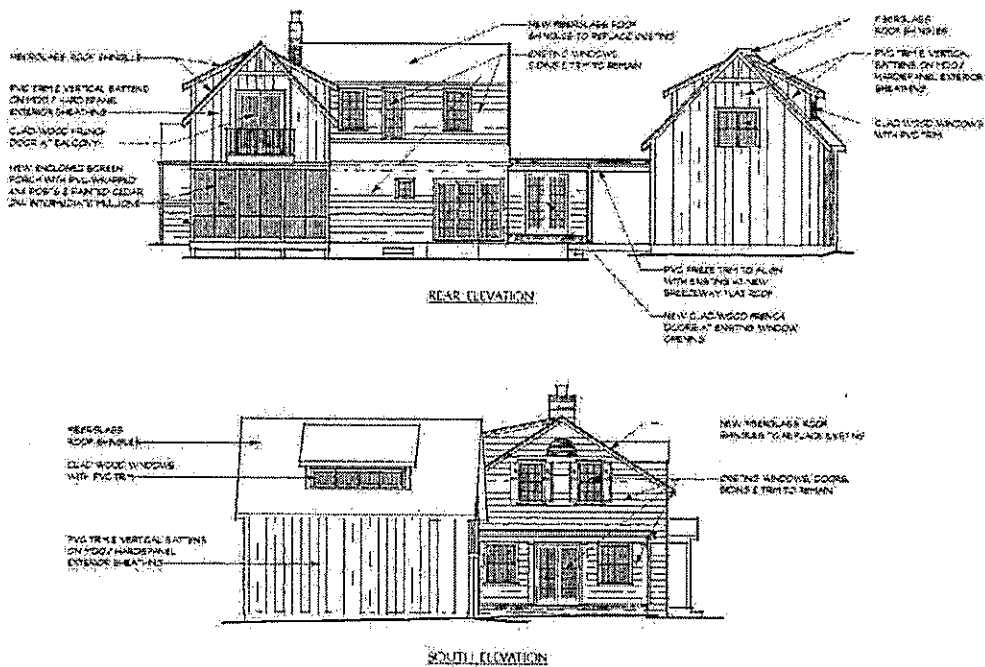
A-4.1 ARCADE/REAR ADDITION
 115 Oak Hills Road, Belpre, MO 63406
 PROPOSED ELEVATIONS
 Scale: 1/8" = 1'-0"
 12/13/12

The original building is small scale, and the proposed rear addition has a complementary small scale. While the ridge line will be higher than the side addition of the existing house, the distance from the street will provide a distant perspective to help keep the focus off of the addition. Further, the gable end that faces the street will be inconspicuous, with siding and a vent and a simple truss that will match one in the garage.

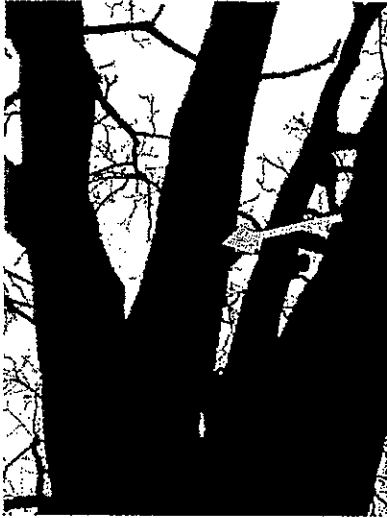
Figure 2

The tree's structure as far as branch architecture is good, but significant defects exist. The tree was struck by lightning at some point. Lightning struck one of the central branches (Figure 2) and ran down and around the branch, following a spiral pattern, jumped to the adjacent limb when it reached the base, jumped to a third limb (both Figure 3) and finally jumped to a fourth limb before traveling down that limb and stopping at its base (Figure 4); there is no sign of lightning injury on the trunk. The woundwood has begun to decay in the upper portions of the limb where the strike originated.

The central limb that was damaged by the lightning strike.

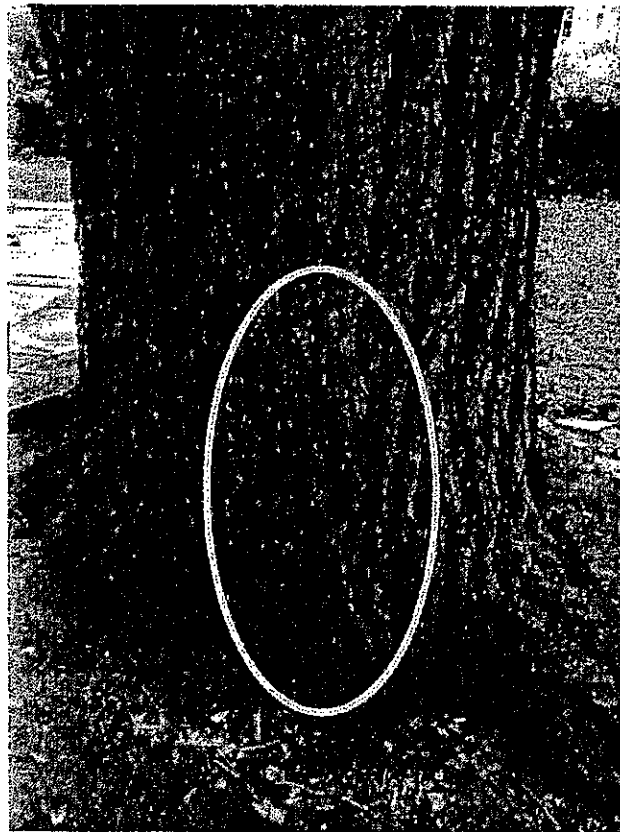
Figure 5

The standard tool arborists use to detect decay is a rubber or plastic mallet. I sounded the trunk with a rubber mallet and found sound wood approximately 320 degrees around the trunk. A questionable area was detected on the north side of the trunk. This area (Figure 5) warrants further investigation. I also sounded the major limb where the strike terminated, which is also the limb closest to the house. It sounded hollow, like a drum.

The north side of the trunk.

Perform ANSI A300 Part 9 Level 3 risk assessment on two locations:

The management recommendations noted above are depicted in Figures 6 and 5, respectively.

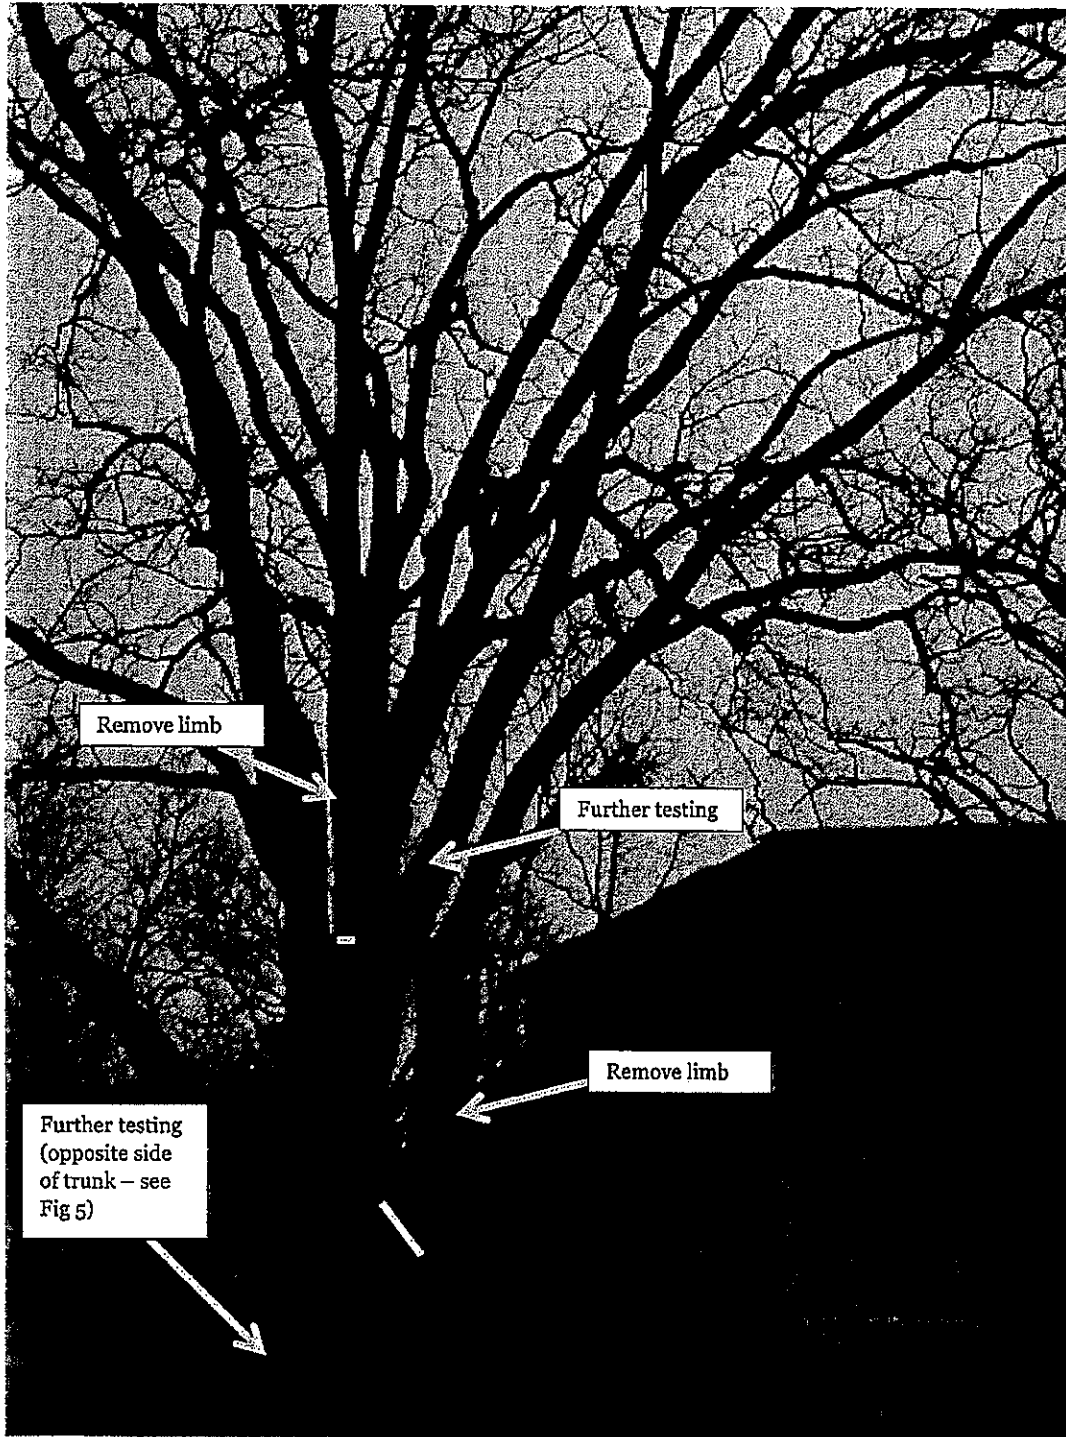
Figure 6

The next lightning-damaged limb closest to the house.

Based on species and location, this tree is obviously at risk for lightning strikes. I would suggest that a lightning protection system be installed to guard against future strikes and further damage.

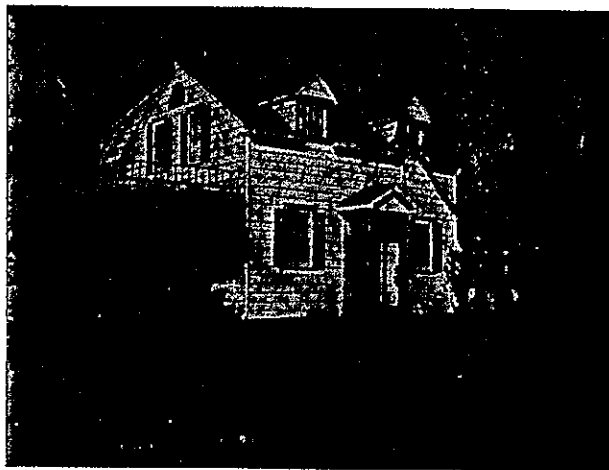
East (primary) and south facades

The house at 315 Great Falls Road is a 1½ story cottage built in the Colonial Revival style. The house faces east toward the street with a side gable roof and twin dormers. It features wide weatherboard siding, 6/6 sash windows, and an array of interesting interior finishes and details such as its open interior plan, added basement, and shutters and doors with tree-shaped cutouts.

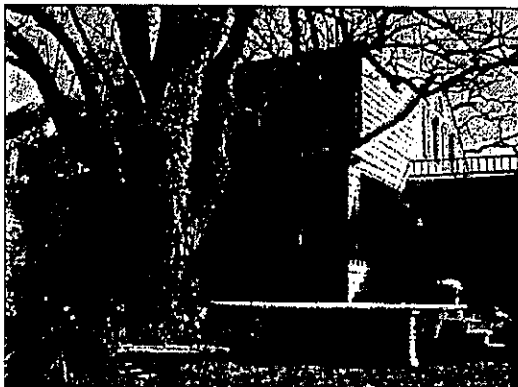
West (rear) façade with large black walnut tree

The diminutive house stands 1½ stories tall and presents a symmetrical Colonial Revival-style primary façade. The side gable roof extends into an integral shed roof to the rear and is covered with composition shingles. The house rests on a poured concrete and concrete block foundation, which supplements an earlier rubble stone foundation, still visible in the basement. Wide modern clapboard siding sheaths the frame construction. Primary windows in the house are 6/6 wood sashes within undecorated wood frames. Each of the two gable roofed dormers on the main facade contains paired six-pane casement windows. Paired windows on the north and south sides illuminate

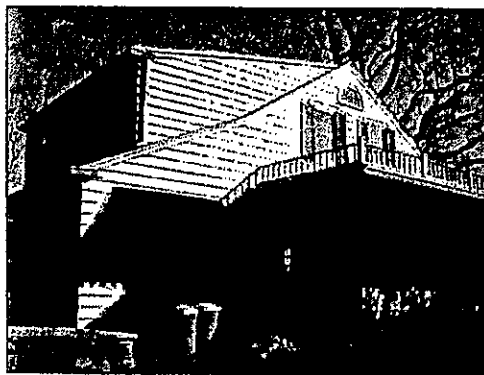
South façade showing southwest corner of porch

One-story projections flank either side of the main building and an added rear shed dormer has increased the interior space on the second floor. The southern ell is an enclosed side porch, which rests on a brick foundation. Cloth awnings shade its extensive fenestration and an open wood balustrade surrounds the flat roof. Double French doors with eight lights each open to the south. This doorway is flanked by large 8/8 sash windows. In the east and west walls, large multi-pane fixed windows allow a considerable amount of light to enter the porch.
